## Preliminary investigation of food safety practices and environmental hygiene in Uyo central abattoir, Uyo, Nigeria

unsanitary management of slaughterhouses and its facilities across the country hence, the aim of this study. The objective of the present study was to assess the hygienic condition of the central abattoir in Uyo, Akwa Ibom State, Nigeria through direct personal observations and pictorial documentation.

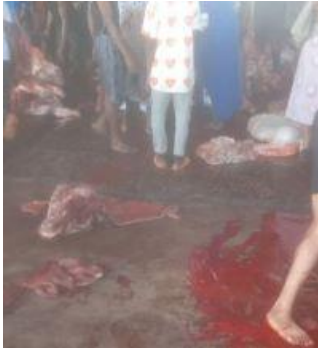
The results of the observation in this study showed that the slaughter hall also served as meat processing room and even as sale points, with the carcass being placed on the floor where the slaughtering took place. Figure I showed that slaughtering of the animals and other post-slaughter operations such as flaying, evisceration, halving and quartering were seen being carried out on the same kill floor with the head, skin and offal kept on the floor of the slaughter house. The slaughter hall lacks a demarcated area for clean and dirty operations. Cattle brought in for slaughter were all placed on the bare floor with no proper immobilisation for restraint, slaughtered, and bled on the same floor with no provision for a hoist to lift the carcass to prevent it from making contact with the bare floor hence, all deboning, removal of extremities and splitting of the carcass were carried out on the dirty floor. Meat inspection is carried out by a veterinarian in this abattoir but since so many slaughtering activities all take place at once in the slaughterhouse, the meat inspection may not be efficient enough and will require more veterinary personnels.

Workers in the abattoir did not use any protective clothing such as helmets/scarves, gloves, aprons, or safety boots with figure I also showing a worker barefooted without any safety boot. There was no running water in the slaughter area either to wash off the dirt and blood after bleeding of the animal to reduce contamination or for the butchers to wash their knives before touching another carcass after handling a different carcass and washing of hands before touching meat. The floor of the slaughter hall was untidy with dirt and blood splashes on the wall. Environmental hygiene of the abattoir premises was poor due to presence of waste dump at the surroundings of the abattoir which can attract flies and other pests into slaughter hall, contaminating the meat being processed.

**Figure I: Unhygienic slaughter practices with flayed skin, bovine head, gastrointestinal tracts being placed on the bare floor. The slaughterhouse is overcrowded and people are not making use of personal protective equipment with a worker even walking barefoot.**

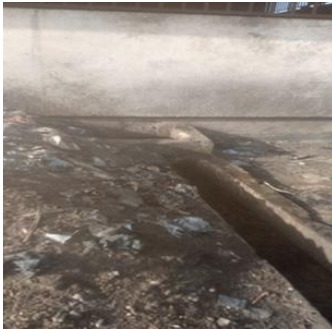
Figure III shows the effluent disposal system of the abattoir where wastewater and blood are discharged into a stagnant drainage without any proper flow through and covering just beside the main slaughter hall. This stagnant drainage is capable of generating foul odour and attracting flies, rodents or other vermin to the slaughter hall.

Waste in this abattoir is disposed around the surroundings and outside of the abattoir building (figures III, IV & V). This facility though built within the last seven years by the State government is rapidly deteriorating as it is the major abattoir serving the Uyo metropolis and surrounding areas.

**Figure III: Stagnant drainage at the side of the main slaughter house and heap of waste lying beside it**

regarding sanitary practices and meat hygiene requires prompt attention by the government, and other regulatory bodies to improve the hygiene and food safety practices among abattoir workers. This will also help reduce the risk of zoonotic diseases. Recommendations such as active implementation of food safety regulations to monitor practices in the abattoir should be put in place. More waste management offices should be tasked with the role of ensuring compliance with proper waste disposal. The drainage system should be restructured for proper effluent disposal and the waste products from the abattoir can be used for biogas production.

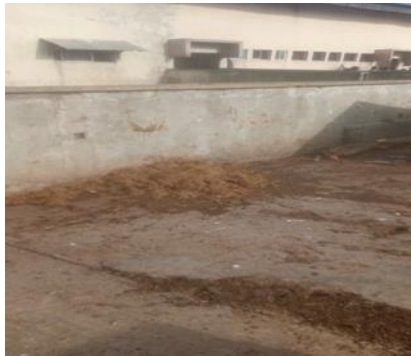
Figure V shows dumping of animal dung not far way from the entrance of the slaughter hall. Such improper method of disposal of animal waste in the abattoir premises causes air pollution and uncondusive inhalation of foul-smelling air to individuals working around these areas. Flies and vermin can breed in such dump site as dung provide favourable conditions for the multiplication of these vectors that act as disease carriers.

**Figure V: Animal dung disposed in front of the slaughter house**

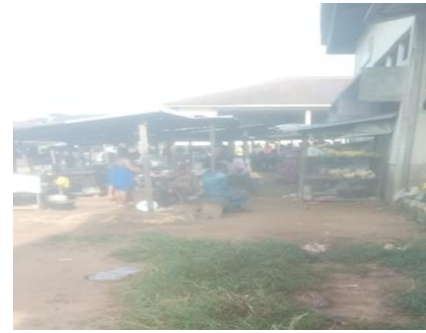
Unideal practices such as the selling of live chicken beside the slaughter hall as shown in figure II underscores the sanitary condition of the slaughter hall premises as the birds were also processed and dressed for sale at the same point for buyers who come into the abattoir to purchase meat. This could also pose a biosecurity threat to workers' health and safety as there can be cross-infection between the birds, animals and humans.

**Figure II: Selling of live birds beside the slaughter hall which poses a biosecurity risk**

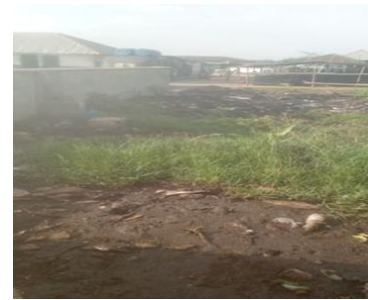
Figure IV shows disposal of solid wastes including bones, hooves, mixed with plastics and other muddy waste in a dump site few metres away from the slaughter hall. This can result in environmental contamination and subsequent degradation posing as hazards to people working in the abattoir. The grasses surrounding this premises can attract rodents which can enter the slaughter hall, acting as source of meat contamination during meat processing in the slaughter hall.

**Figure IV: Improper waste disposal in the abattoir premises**
